AMC BOS™ recovers abandoned hole and boosts productivity

Project: Resolution Copper's Superior Mine

IMDEX Borehole Optimisation System™ (BOS)

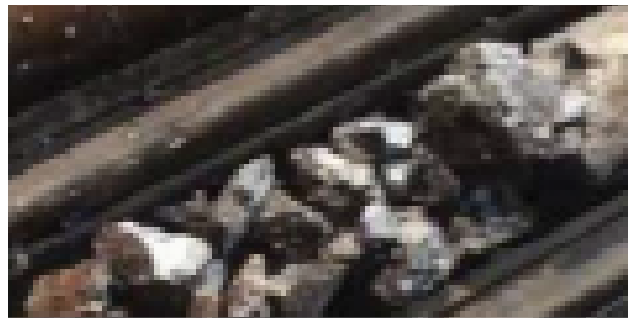
Before: Formation before deploying AMC BOS

The drilling contractor and crew were unable to advance for two weeks on a drill hole with traditional grouting methods due to sloughing and caving around the drilled casing.

Resolution Copper had battled these issues over a 10-year period. The lack of adequate cement seal around the casing was causing ongoing ground control issues as they tried advancing directly from a cut-out of the window wedge down at 2,732 ft.

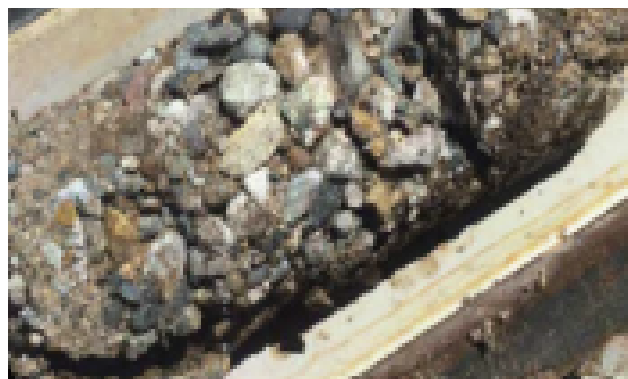
After: Using AMC BOS stabilised the formation

- AMC injected the hole using the AMC BOS UNIT and conditioned the borehole for 15 minutes before the unit was pulled and the crew started drilling. An initial 1.5' of cave material was recovered, held together by AMC BOS FIX. The biggest challenge facing the drill crew was the low 50% fluid returns, with 50% leaking off behind the casing. Following a second injection, fluid leakage around the casing slowed, and the hole continued to advance an additional 20 ft through the caving and sloughing zones.

- AMC BOS was able to stabilise the caving and broken ground, allowing the drill crews to advance the hole a further 93 ft in one shift.
